ET News & Letter

January, 1960

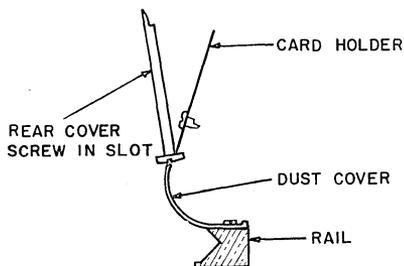
EASY ADJUSTMENT - LINE GAGE CARD HOLDER

The Model C rear cover screw (PN 1117337) may be used as a lever to adjust the line gage card holder. By inserting the head of this screw in the dust cover slot as illustrated, the card holder can easily be brought away from the platen.

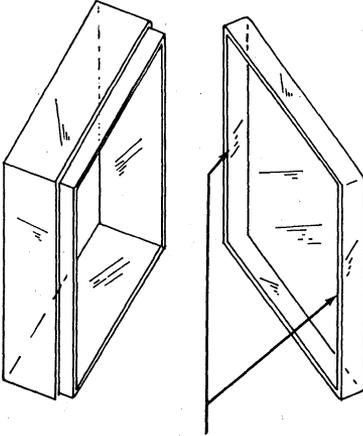
QUICK-FIX FOR PLASTIC PARTS BOXES (LOOSE LIDS)

To make plastic parts box lids snap on securely, touch the lids with a soldering iron as illustrated. A tiny notch melted on opposite inside surfaces of the lid makes a snug, snap-on fit. Wear safety glasses when using soldering iron.

Touch these points on inside surface with soldering iron.

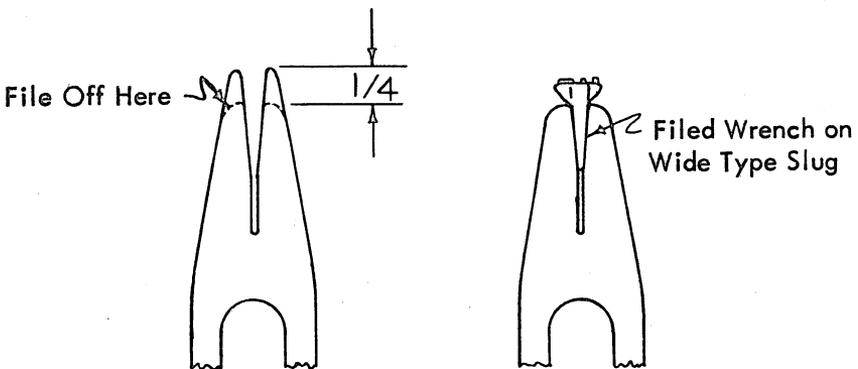
ALIGNING WRENCH MODIFICATION FOR WIDE TYPE FACES

On 4 and 5-unit characters, the type face is often wider than the type slug, preventing the aligning wrench from grasping the type slug from the rear. The aligning wrench may be filed off $\frac{1}{4}$ " as illustrated to enable the jaws of the tool to grasp these typebars from the rear.

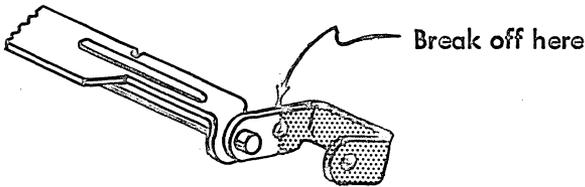
EASY METHOD - LIFT BAIL REPLACEMENT

When replacing a ribbon lift bail, Part No. 1100526, on a Model A or B Executive with carbon ribbon only, break off a portion of the R. H. ribbon feed arm, as illustrated.

The old one can be broken off in the machine and the new one broken off before installing. The bail may then be removed by loosening the R.H. bail bearing and disconnecting the links and spring.

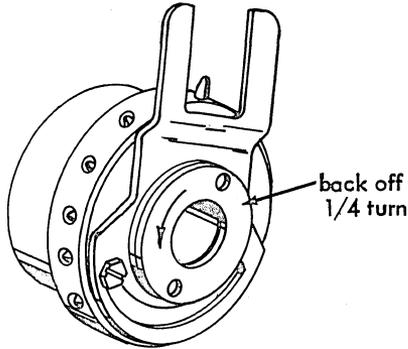
PIN FEED PLATEN - PINWHEEL BINDS

Sometimes binds occur in the pins of the pinwheel assemblies, Part Numbers 304871, 304872, 1107537, and 1107358. These binds may often be overcome by loosening the inner plate, as illustrated.

This plate is threaded and may be backed off 1/4 turn with gas pliers to open up inside clearances in the assemblies. Caution: Do not remove this plate from the assembly as it is difficult to replace.

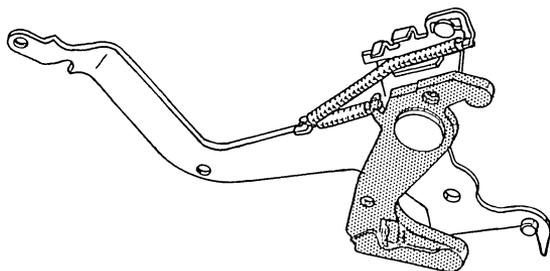
TRIP LEVER SPRING COMING OFF - TYPAMATIC OPERATION

Try installing a Model O1 typebar spring, Part No. 1090341, cut to 1 1/2" to 1 5/8" long, as illustrated.

Remove the regular trip lever spring, Part No. 1105906, before installing the longer spring. Caution: A change in touch will result if the new spring is too short.

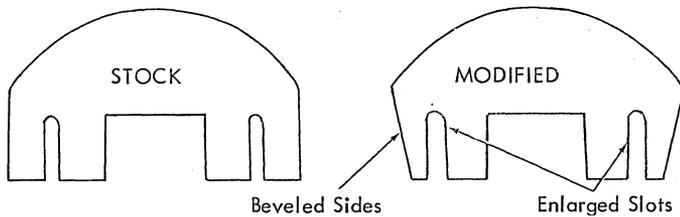
QUICK INSTALLATION - UNDERPRINTING SHIELDS

Modify underprinting shields, Part No. 1260385, as illustrated for easy insertion and adjustment.

The beveled sides make insertion easier and the enlarged slot makes vertical adjustment easier after the shield is in place.

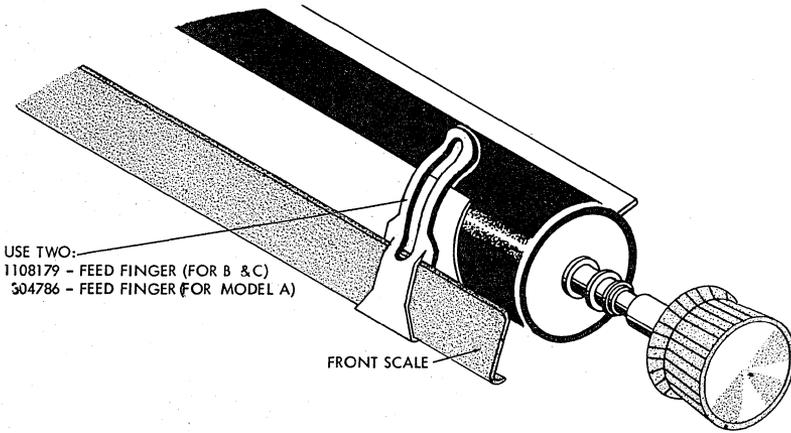
Try inserting a feed finger for pin feed platens on each side of the front paper scale as illustrated. Some forming of the finger foot to

fit the scale closely may be necessary to clear any obstruction to a free carriage travel.

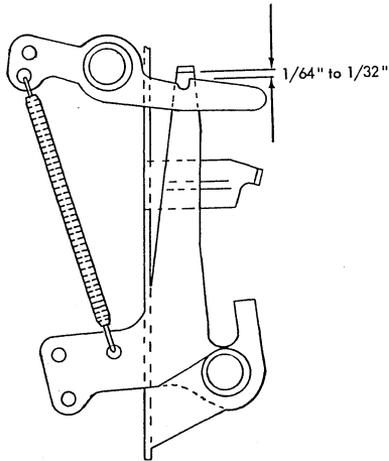
To check the Model C clutch for unlatching during the last $\frac{1}{64}$ " to $\frac{1}{32}$ " of the carriage travel, do the following:

1. Hold the carriage to the right.
2. Push the rear of the clutch lever to the left, almost to the latching position.
3. The rear of the clutch latch should clear the upright lug of the clutch lever by $\frac{1}{64}$ " to $\frac{1}{32}$ ", as illustrated.

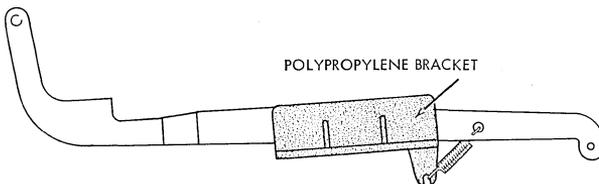
MARGIN SET LEVER BRACKET CHANGED TO POLYPROPYLENE

The margin set lever bracket, Part No. 1115572, has recently been changed to polypropylene. The part number remains the same. To prevent spreading of the polypropylene, washers are now used between the head of mounting screws and the bracket. Add washer Part No. 1091338 to the 1960 Parts Manual.

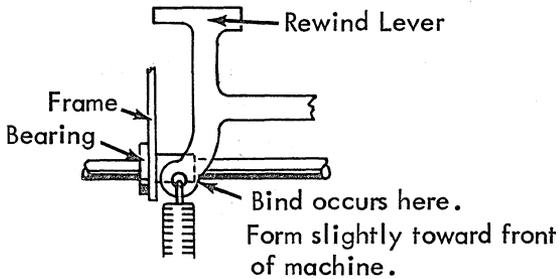
(Figure 1)

CHECK FOR REWIND LEVER BINDS WHEN INSTALLING NEW STYLE RIBBON FEED AND REVERSE SHAFT BEARING

When the new type L.H. ribbon feed and reverse shaft bearing, Part No. 1118191, is being installed, it may be necessary to slightly form the rewind lever, Part No. 1118300, away from the new bearing. The rewind lever may bind on the bearing, causing rapid rewind back to the right (see Figure 1).

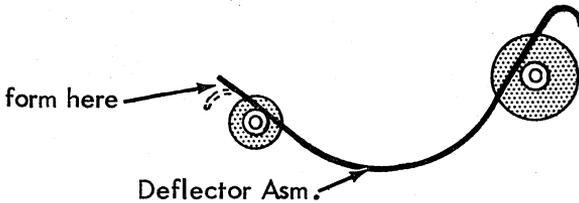
FORM DEFLECTOR FOR FORMS TEARING ON ROLLBACK

Tearing of continuous forms during rollback may be traced to the form catching on the front lips of the deflector. The front lips may be formed outward as illustrated to remedy this condition. CAUTION: After forming, be sure the front scale clears all obstructions without binding.

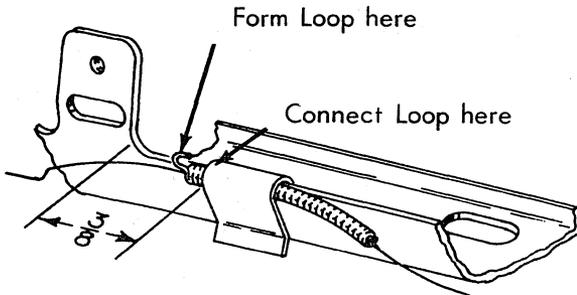
If you have service calls due to the repositioning indicator wire breaking, try the following corrections:

1. If the clip (P/N 1110453) does not hold the cable securely, form a loop in the cable as shown in the illustration below.
2. Position the clip $3/8"$ to the right of the tab on the front rail dust cover (see illustration).
3. Place left end of the outer cable flush with the left side of the retaining clip.
4. Lubricate with #6 oil during each inspection.

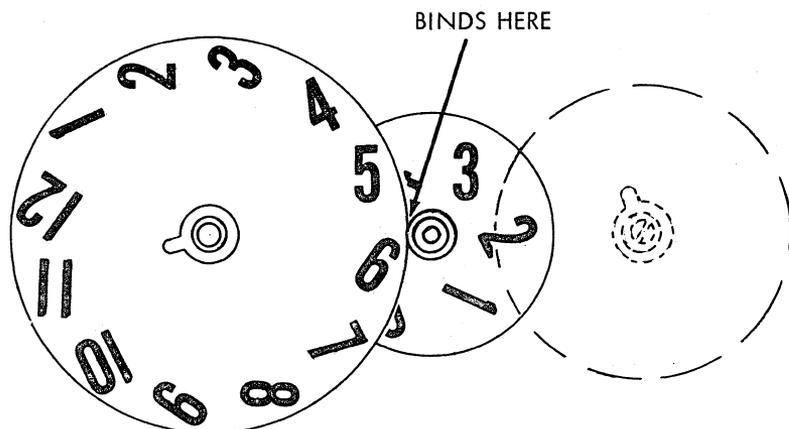
Intermittent loss of time is often the result of the plastic hours disc binding under the tens disc retaining flange.

This obscure trouble is eliminated by reducing the diameter of the hours disc by approximately $1/32$ inch. A file or abrasive paper may be used for this purpose (see illustration).
