Some Failure Modes of Double Diffused Silicon Mesa Transistors

A. A. BERGH
Bell Telephone Laboratories, Inc.
Allentown, Pennsylvania

ABSTRACT

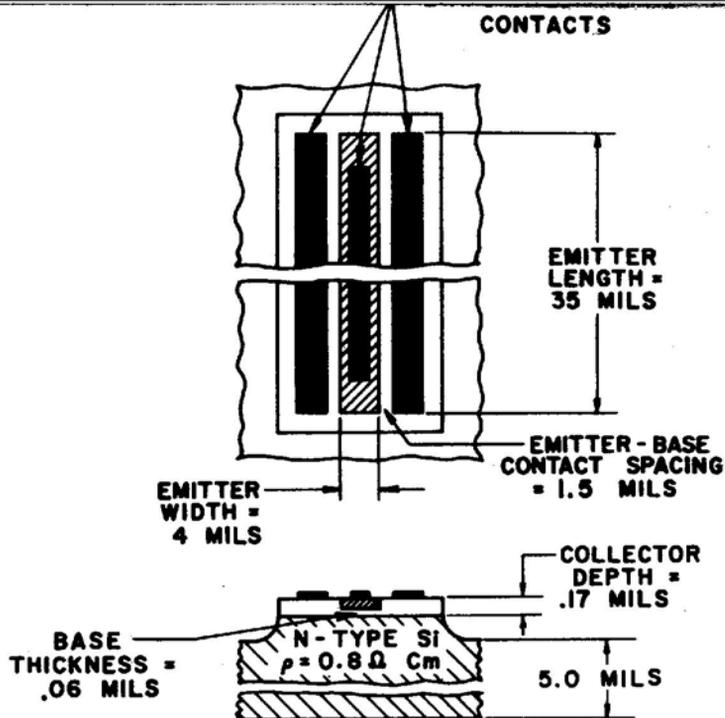
FIG. 1. Medium Power n-p-n Silicon Mesa Transistor

Figure 1 shows the top view and the cross section of the silicon wafer. A schematic diagram of the header assembly is given in Figure 2. The header was

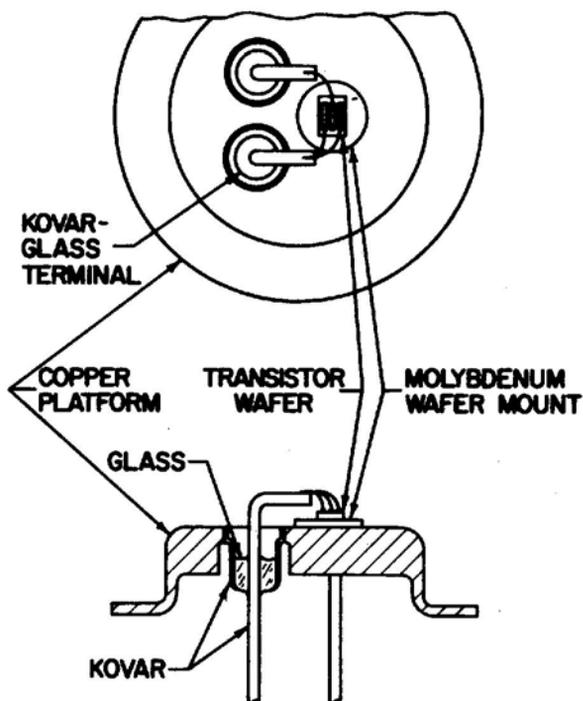
FIG. 2. Schematic Diagram of the Header Assembly

gold plated before mounting the silicon wafer. A tubulated copper can precleaned in hydrogen at 450°C was cold-welded to the header assembly. The important steps in the encapsulation process are listed below:

1. Following a light etch in dilute HF the header assembly was heated in wet oxygen at 250°C for 16 hrs.
2. After welding the can to the header the device enclosure was evacuated to lower than 10^{-4} torr of pressure at 300°C for 40 minutes and sealed or backfilled with different gases.
3. The encapsulated devices were heated for several hours at 250°C, and tested for leakage and mechanical strength.

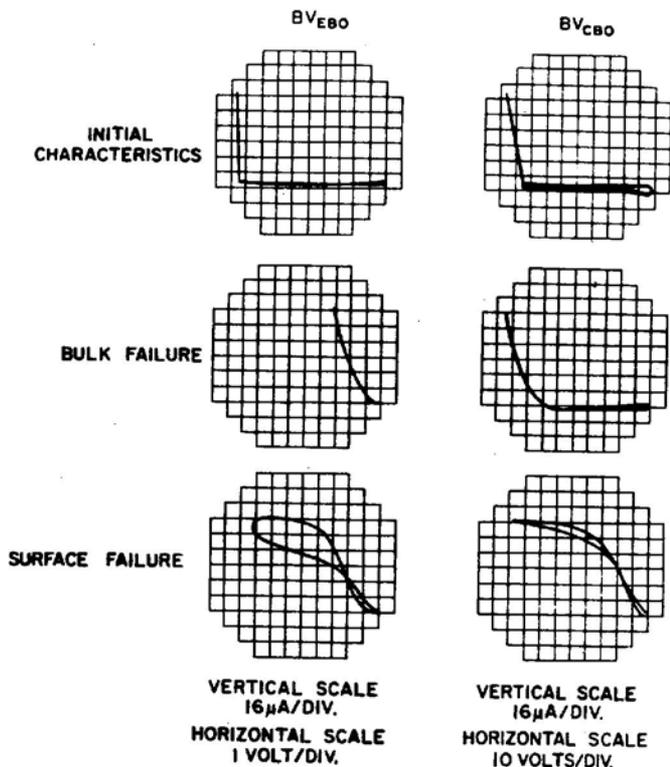
FIG. 3. Typical Reverse Characteristics

Typical reverse characteristics of the transistor junctions for bulk and surface failures and recovered devices are shown in Figure 3.

Typical values of surface degradation and recovery are shown in Table 4. Changes are most pronounced at the collector junction. Instantaneous recovery is obtained by opening the can and blowing dry gas over the transistor wafer. The loopy reverse characteristics shown in Figure 3 could be re-established by testing the device in a high relative humidity ambient and complete recovery was observed after lowering the humidity level of the ambient. The above results indicate that surface failure is caused by water. Since water was found only in the oxygen backfilled can, there must be some hydrogen in the device ambient. The transformation of hydrogen into water thus eliminated the bulk failure and introduced the surface degradation. The source of hydrogen in the enclosure is probably the copper can and the gold plating on the header and can. In order

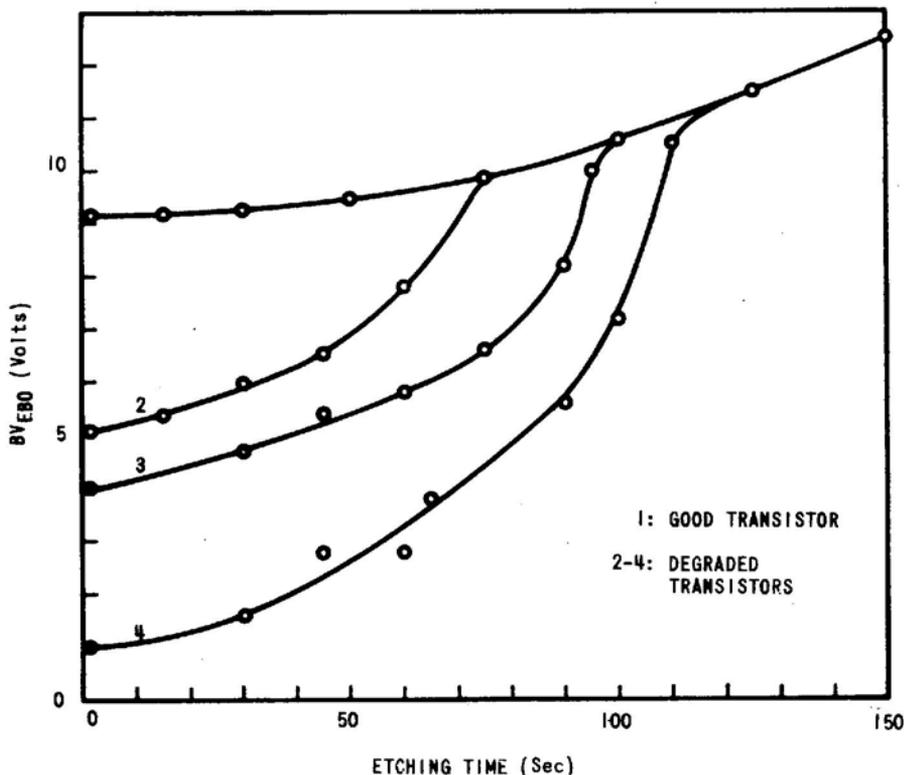
FIG. 4. Recovery of BV_{EBO} During Etching

After aging and testing, the cans were removed and an attempt was made to recover the device by etching. The header was coated with Apiezon-W wax to avoid contamination during etching. The composition of the etchant was 50:50:1 HNO_3 (60%) : water : HF (49%). A rinse in a 10% solution of KCN and DI water preceded and followed each etching. The time necessary to recover bulk failures is increased for decreasing BV_{EBO} values as shown in Figure 4. While BV_{EBO} increased leakage currents could be only partially recovered as shown in Table 3.

Similar recovery was obtained by heating the degraded units in closed cans at 300°C for over 70 hours. Although BV_{EBO} increased to values higher than 7 volts within the first 18 hours, I_{EBO} was typically an order of magnitude higher than the initial value even after 72 hours.

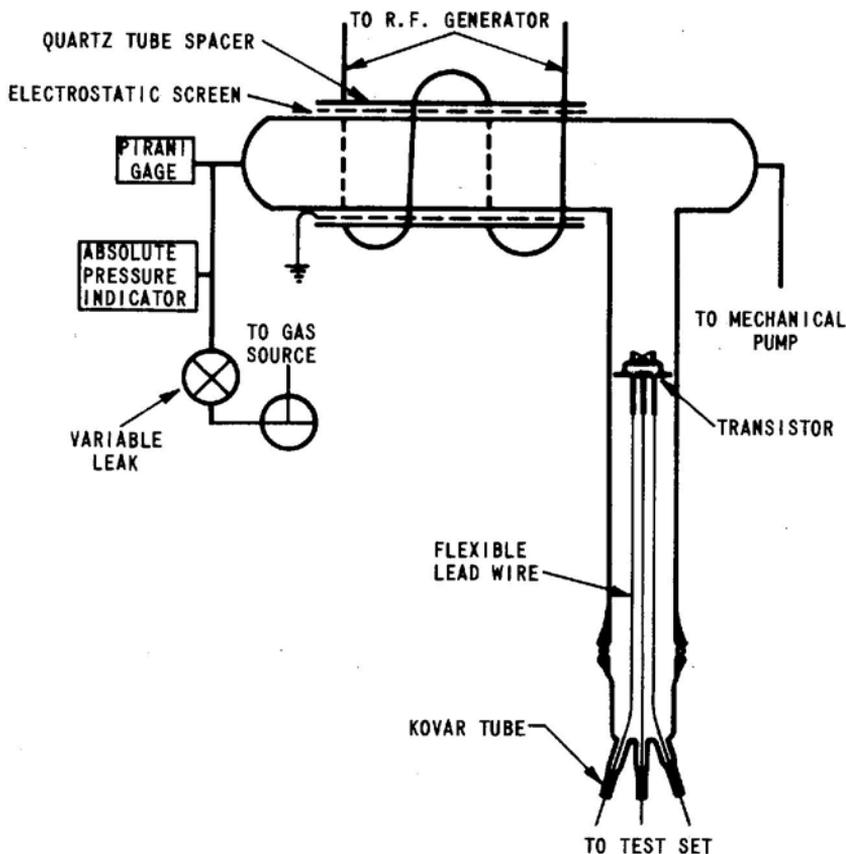
FIG. 5. Schematic Diagram of the Electrodeless Discharge Apparatus

Atomic hydrogen was generated in the ac field of a 10-16 mc radio frequency generator. A schematic diagram of the electrodeless discharge apparatus is shown in Figure 5, and the system is described in detail elsewhere.⁽²⁾ A continuous flow of hydrogen was maintained by a mechanical pump and a variable leak, keeping the pressure close to 0.2 torr. The transistor was placed into a side arm and it was connected to the power supply and/or the test set with flexible lead wires. Since the atomic hydrogen was generated in the area confined by the electrostatic screen, it could reach the transistor only by diffusion. The concentration of atomic hydrogen at the device was therefore determined by its position in the side arm which could be adjusted with a removable outside magnet. The concentration of the atomic hydrogen is important to control the temperature of the device. Recombination at the contacts, lead wires and other high recombination generates excess heat and destroys the device. The atomic hydrogen concentration was adjusted so that the junction temperature should not exceed 300°C during the simultaneous application of atomic hydrogen and power aging.

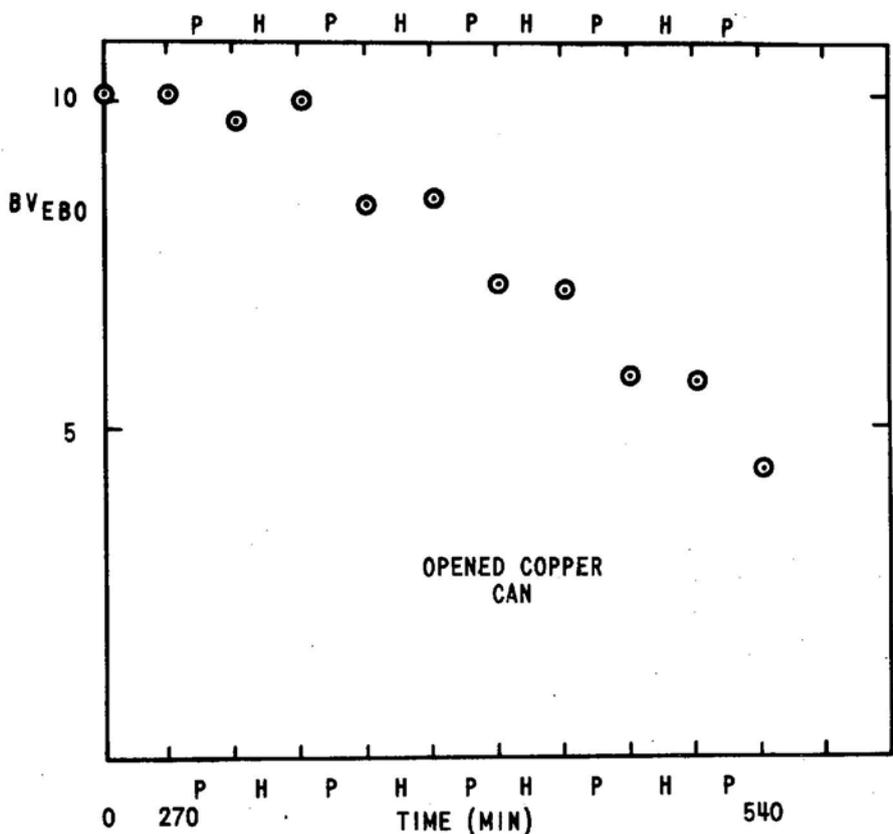
FIG. 6. Change in BV_{EBO} During Alternating Aging for 30 Min. Periods in Atomic Hydrogen (H) and Power (P). (20C Type Medium Power Silicon n-p-n Mesa Transistors)

In order to determine the effect of high current density on the deterioration of the device, exposure to atomic hydrogen was alternated with power aging for

30 minute intervals for a device with opened copper can. The results are shown in Figure 6. Exposure to atomic hydrogen had almost no effect on BV_{EBO} . A large decrease resulted, however, during the subsequent power aging. On the other hand, power aging had no effect unless preceded by exposure to atomic hydrogen in the presence of copper:

The results of the atomic hydrogen experiments can be summarized as follows: (1) Emitter degradation occurs only during power aging if the application of high current density is accompanied or preceded by the exposure to atomic hydrogen in the presence of copper; (2) The degradation is identical to that experienced in bare copper cans with oxygen free ambient. This implies that: (1) Atomic hydrogen transfers copper from the exposed metal surface to the transistor wafer; and (2) The copper over the silicon wafer degrades the emitter junction during power aging. (3) The similar results with can material (OFHC grade Cu) and spectroscopic grade copper indicate that Cu and not another impurity in the can is causing the emitter degradation.
